# Relationship of Microstructure to Properties of HIP and Weld Clad Alloy 625 in Sour Environments

## ABSTRACT

A study of the clad alloy 625 deposited by HIP and weld overlay on 4130 and 21/4Cr-1Mo steels was conducted to evaluate the effect of cladding process on microstructure, mechanical, corrosion and stress corrosion cracking (SCC) properties relating to sour gas production service. The results showed that the microstructure of the clad and interface produced by the two cladding processes are considerably different and had a direct effect on the properties. The clad produced by HIP had a homogenous structure which showed superior resistance to pitting, hydrogen disbond and SCC. In contrast, the HIP process resulted in a high concentration of coarse carbides resulting in poor mechanical properties of the clad/steel interface properties than in the weld clad. The segregated cast structure of the weld overlay alloy 625 contributed to the reduced resistance to corrosion and SCC of the weld clad compared to HIP clad. The weld clad interface also had fewer carbides which provided good mechanical integrity. Analysis of the microstructural characteristics and properties of the two c

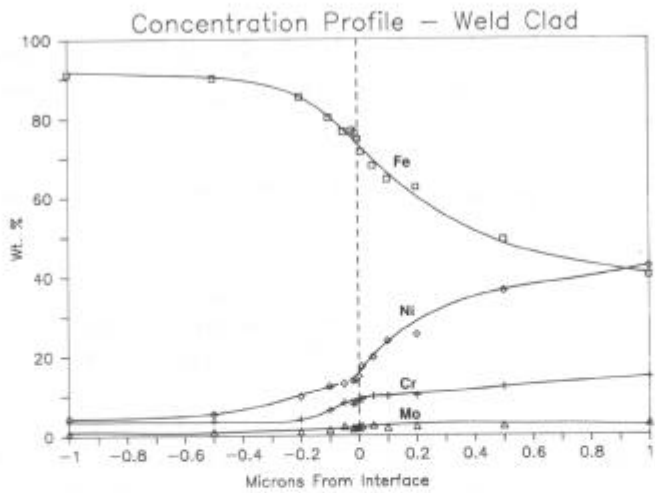
Figure 4: EDS profile of the elemental concentrations across the weld clad interface.<sup>[4]</sup>

Composition variation across the interface was determined by EDS in the TEM using a 40 nm probe, Figure 4. Overall transition in composition occurred over approximately a 5  $\mu\text{m}$  distance. The concentration profile was not symmetric about the interface in that the composition of the ferrite was modified for only a 1  $\mu\text{m}$  distance from the interface while the composition in the nickel side was modified over a larger distance (about 4  $\mu\text{m}$ ). The asymmetry is explained based on the fact that the "interface" observed in the SEM images is a demarkation of the BCC and FCC structures and not that of "steel" and "Alloy 625". Dilution of steel with nickel at the interface region depresses the  $M_s$  temperature and converts of the original steel region to austenite causing the asymmetry.

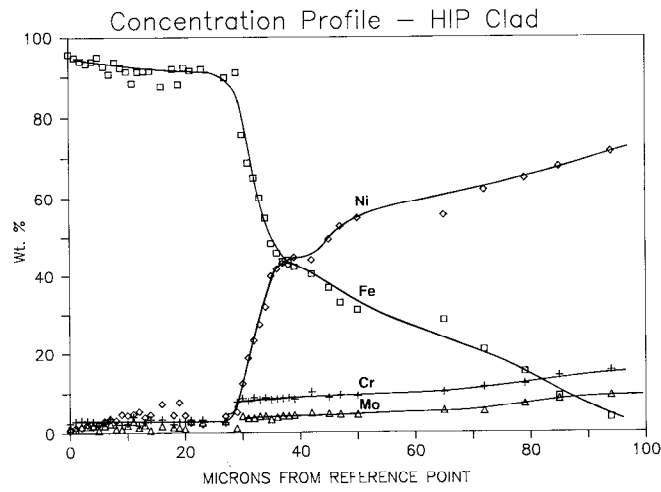
Figure 7: EDS profile of the elemental concentrations across the HIP-clad interface.<sup>[4]</sup>

Concentration profile was also determined across the clad interface using X-ray microanalysis Figure 7. The profile shows that most of the major compositional transitions take place over a 30  $\mu\text{m}$  region. As observed in the weld clad samples, the concentration profile was not symmetric about the interface and can be, again, explained as due to the conversion of the steel to austenite at the interface region.
