## MICROSTRUCTURAL INVESTIGATIONS OF ELECTRON BEAM WELDED ALLOY 718

M. Sundararaman and P.J. Potdar

Materials Science Division  
Bhabha Atomic research Centre  
Mumbai 400 085, India

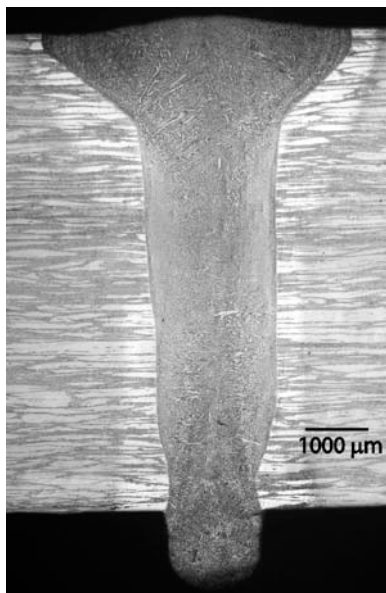
Figure 1. Cross section of electron beam welded Alloy 718.

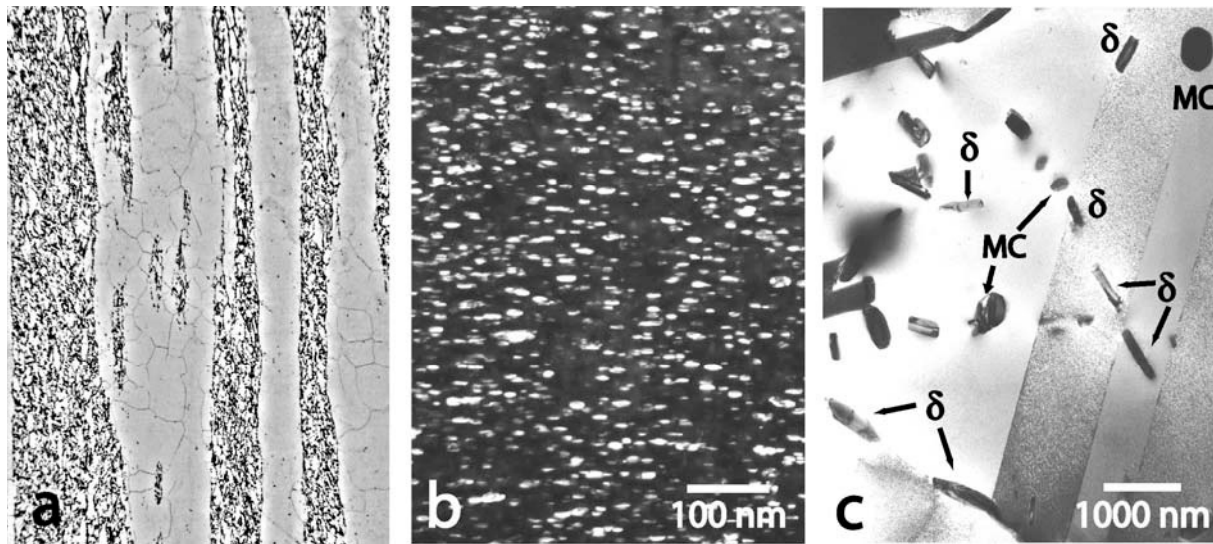
Figure 2. Microstructure of Alloy 718 base material; (a) Bimodal distribution of grains, (b) uniform distribution of  $\gamma'$  particles and (c) MC carbides and  $\delta$  particles in the matrix.

The microstructure of base material shown in figure 2 gives the appearance of banded structure with light and dark regions. Equiaxed grains could be noticed within the light as well as the dark bands with the light areas having a larger grain size compared to dark areas. Such duplex structures have been reported in samples deformed in hot compression at temperatures above 1000° C during alloy processing [13]. This microstructure could have been produced during the processing route. The standard heat treatment is not expected to alter this structure since the temperatures involved during the heat treatment are below 1000° C[13]. TEM examination showed a uniform distribution of  $\gamma'$  particles in the alloy with an average diameter of ~12 nm (Fig. 2b). Some primary MC carbide particles and also blocky and needle shaped  $\delta$  particles could be seen within the matrix as well as at the grain boundaries.

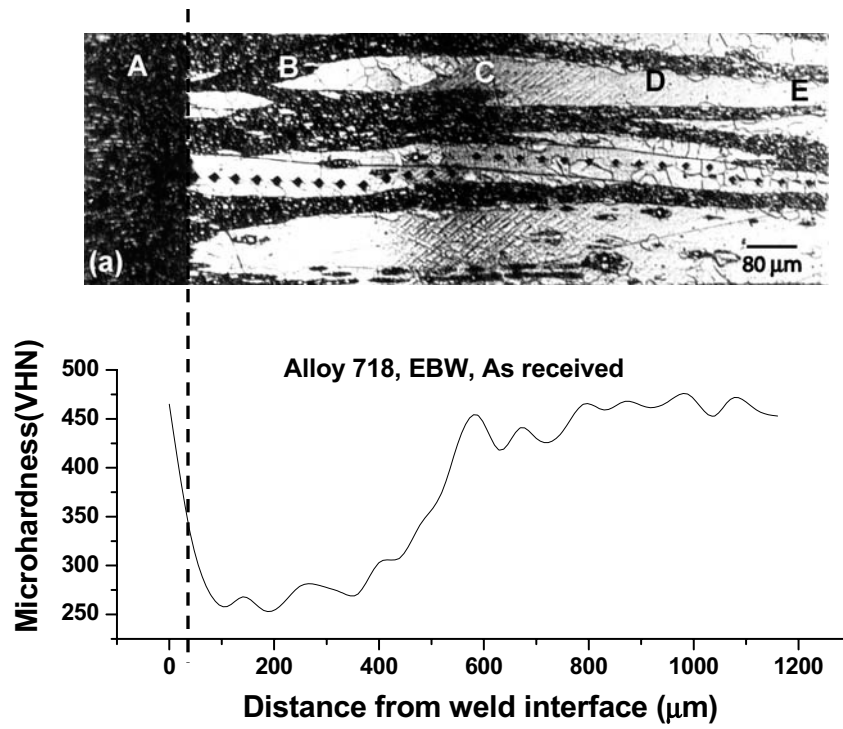
Figure 3. Microhardness profile across the weld structure; (a) optical micrograph and (b) microhardness plot.

No macro or micro cracking were observed in the EB welded specimen at the optical level. Fig. 3a is a typical micrograph showing all regions, from fusion zone to the base material through HAZ. No grain growth appears to have occurred in the HAZ region. Extensive deformation bands / twins could be noticed within a small band of region of thickness ~200  $\mu$ m, at a distance

of about  $\sim 400 \mu\text{m}$  from the fusion zone-HAZ interface. The detailed microstructure of this region is discussed later. A micro-hardness traverse taken across the weld from the fusion zone to the base matrix is shown in figure 3b. The indentation spots are shown in the optical micrograph in figure 3a. The micro-hardness in the fusion zone region is high and comparable to that of base material. It started decreasing near the fusion zone-HAZ interface, reaching a constant value of  $\sim 250$  VHN in the HAZ region up to a distance of  $\sim 400 \mu\text{m}$  from the interface. The hardness values gradually started increasing thereafter and reached the base material value at a distance of  $\sim 600 \mu\text{m}$  from the fusion zone interface. It is clear from this figure that the region where the hardness has started increasing corresponds to the area C where extensive deformation bands are noticed.

Detailed TEM examination of specimens revealed different microstructures at various distances from the fusion zone. Random distribution of high density of dislocations could be noticed within the fusion zone (region marked A in figure 3a, Fig. 4). Inter- and intra-granularly

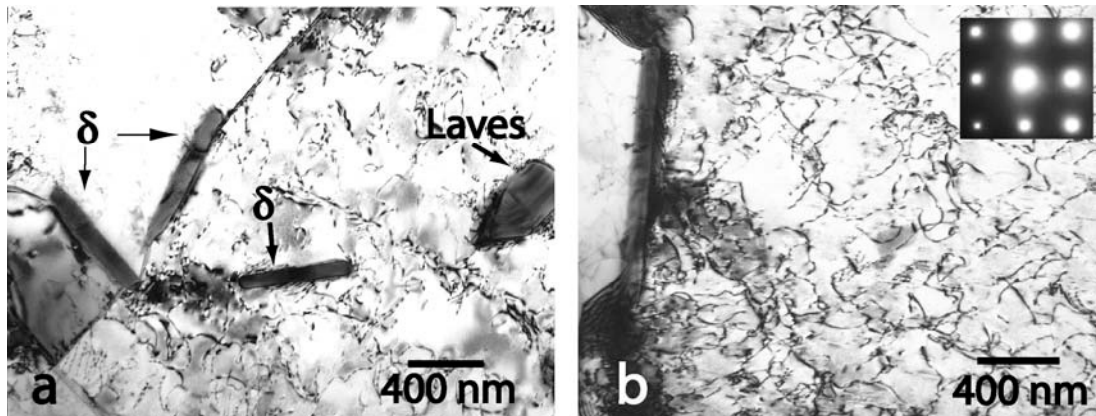
Figure 4. Microstructure of fusion zone in as welded Alloy 718 showing uniform distribution of high density of dislocations. The Laves phase and  $\delta$  particles could be seen in (a).

distributed primary carbides, Laves phase and  $\delta$  particles were also seen. No evidence of superlattice reflections corresponding to  $\gamma''$  particles could be observed in the selected area diffraction (SAD) pattern (inset in figure 4b) indicating that its precipitation has not occurred during solidification. Similar microstructure evolved in the heat affected zone close to the interface (Region B in figure 3a). However, the dislocations are arranged predominantly in planar arrays here (figure 5a) indicating that the stacking fault energy of the matrix is low [14]. The variation in stacking fault energy between different regions could be attributed to the difference in the matrix composition between fusion zone and HAZ as a result of profuse

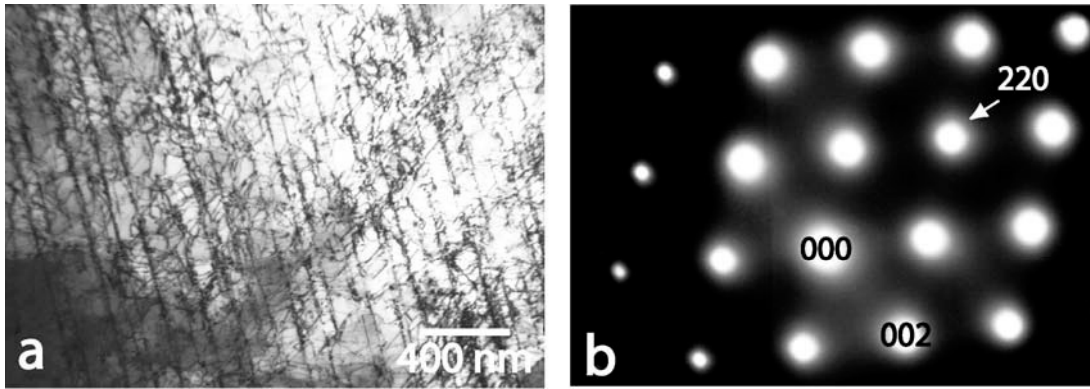
Figure 5. Microstructure of region B in figure 3a; (a) planar arrangement of dislocations and (b) [1-10] zone axis SAD pattern indicating absence of  $\gamma''$  reflection.

precipitation of primary carbides and Laves phases in the fusion zone during solidification. The absence of superlattice reflection corresponding to  $\gamma''$  particles indicated that these precipitates have completely dissolved (Fig. 5b). In the region marked **C** in figure 3a, uniform distribution of  $\gamma''$  particles could be observed (Fig.6) and its average size is very close of the base material (table 2). The dislocations are often confined to deformation bands lying on  $\{111\}$  planes and most of them have split into partials. In the region shown **D** in figure 3a, the dislocation density has reduced considerably and its arrangement is random (fig. 7). The  $\gamma''$  particle size in this case is similar to that of base material (table 2). The distribution of carbides and  $\delta$  particles in the HAZ region is very similar to that observed in the base material. The microstructure in region marked **E** in figure 3a (far away from the fusion zone interface) is similar to that of base material described in figure 2.

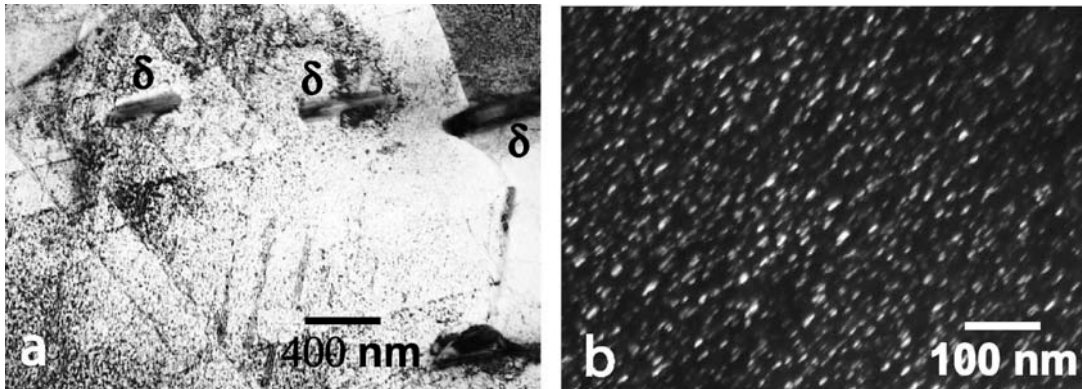
Figure 6. Microstructure of region C in figure 3a; (a) deformation bands and faulting within the matrix and (b) uniform distribution of  $\gamma''$  particles.

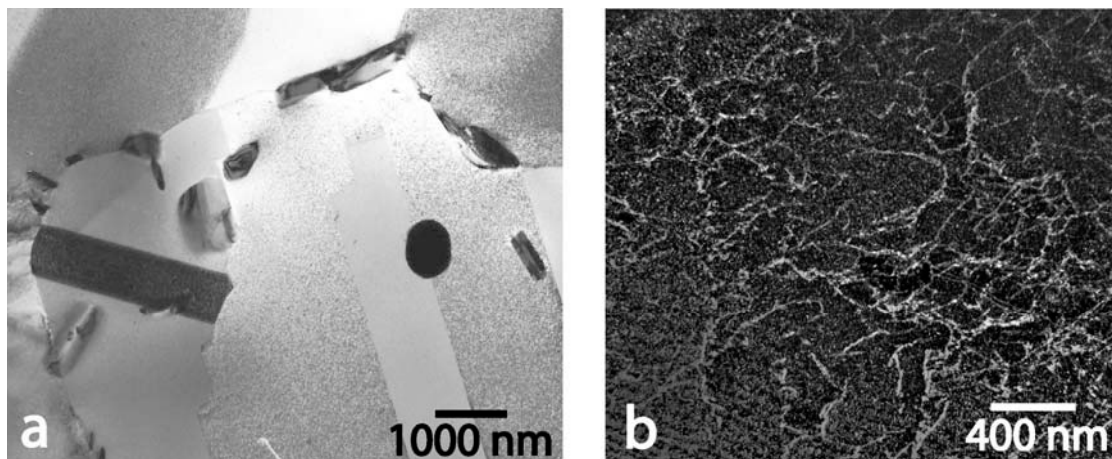
Figure 7. Microstructure of region D in figure 3a; (a) bright field micrograph and (b) distribution of dislocations in the matrix.

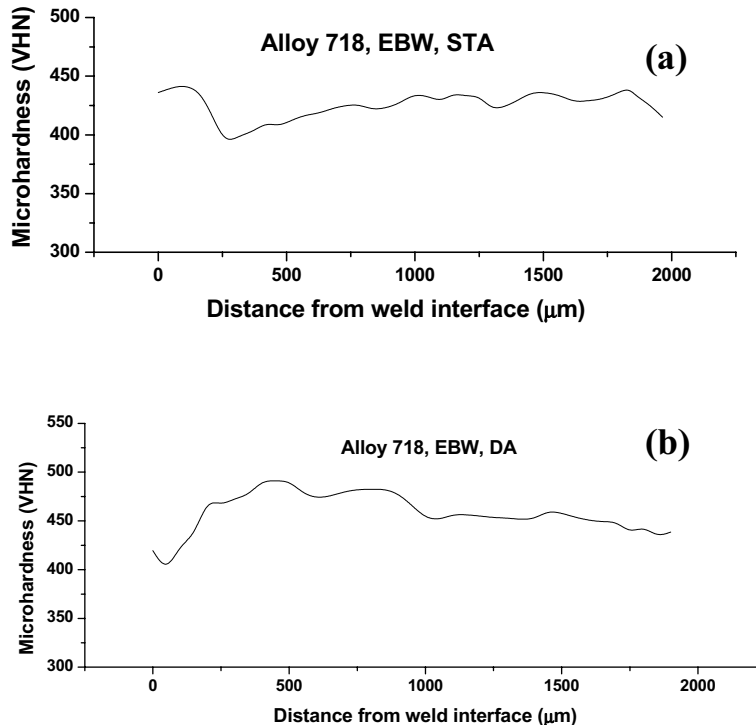
Figure 9. Microhardness profile of (a) DA and (b) STA specimen.

The post weld heat treatments (**DA** and **STA**) did not result in the generation of cracks either in the fusion zone or heat affected zone in the material. In fact, the narrow band of deformed region seen in the HAZ in the as welded sample has disappeared after post weld heat treatment (Fig. 8 and Fig. 9). Micro-hardness profile remained nearly flat across the HAZ region in both **DA** and **STA** specimens though the hardness values were slightly lower for **STA** specimens compared to **DA** specimens. TEM examination of fusion zone in **DA** and **STA** samples revealed uniform

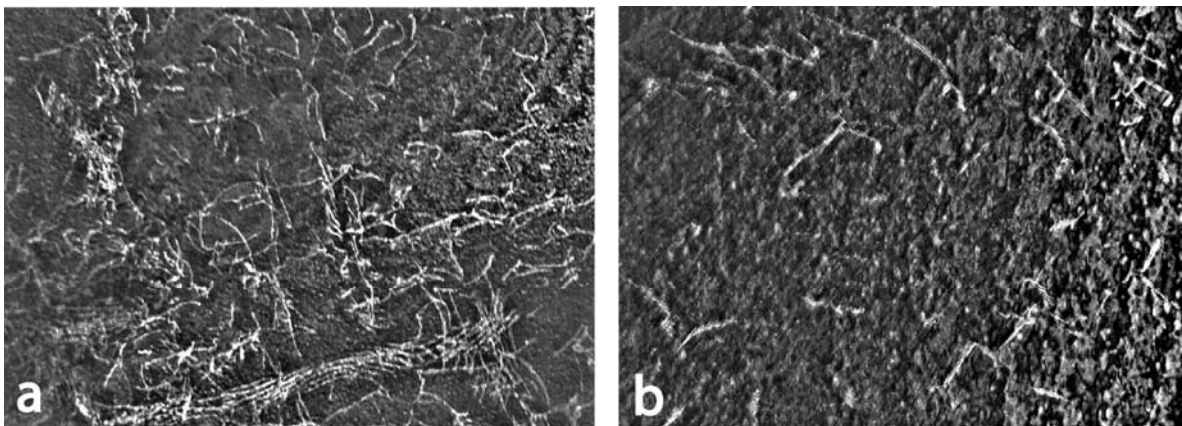
Figure 10. Distribution of dislocations in fusion zones in (a) DA and (b) STA specimens.

distribution of high density of dislocations in the matrix (Figures 10a and 10b). However, in the HAZ and the base material, the dislocations appeared to have almost completely annealed out (Fig. 11a and 11b). Precipitation of uniform distribution of  $\gamma''$  particles has occurred in all regions of the specimen, from fusion zone to the base material. From the table 2, it is clear that there is no variation in  $\gamma''$  particle size (11.6 nm) in the entire sample in the STA specimen while in the case of DA specimen,  $\gamma''$  particle size in the fusion zone is comparable to that of STA specimen but its value has increased in the base material. This could be attributed to two standard ageing treatments seen by the base material of DA specimen without any intermediate solution treatment. This variation in size has not brought about any significant change in the hardness value.

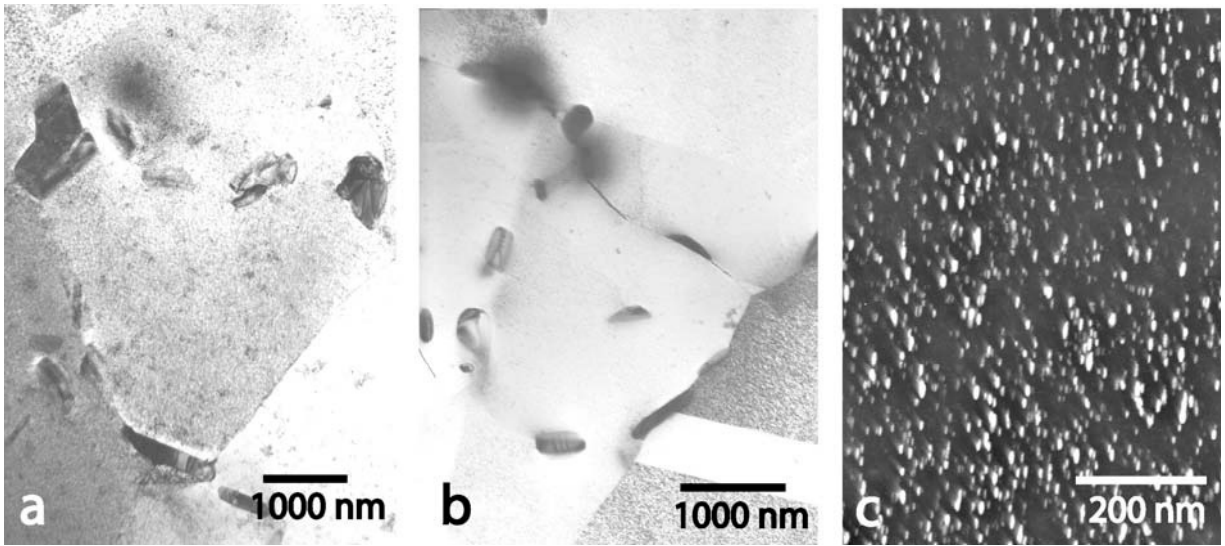
Figure 11. Typical microstructure of HAZ in (a) DA and (b) STA specimens. (c) Precipitation of  $\gamma''$  particles in HAZ after post weld heat treatment.

Detailed TEM investigation revealed that  $\gamma''$  particles have completely dissolved up to a distance of about 300  $\mu\text{m}$  from the weld interface and the particle size gradually reached the base metal value at about 600 to 650  $\mu\text{m}$  from the fusion zone interface. This observation is indicative of
