EFFECT OF MICROSTRUCTURE ON FATIGUE CRACK GROWTH RATE

OF ALLOY 718 AT 650°C

A.K. Koul and J.-P. Immarigeon

Structures and Materials Laboratory  
National Aeronautical Establishment  
National Research Council of Canada  
Ottawa, Ontario, Canada

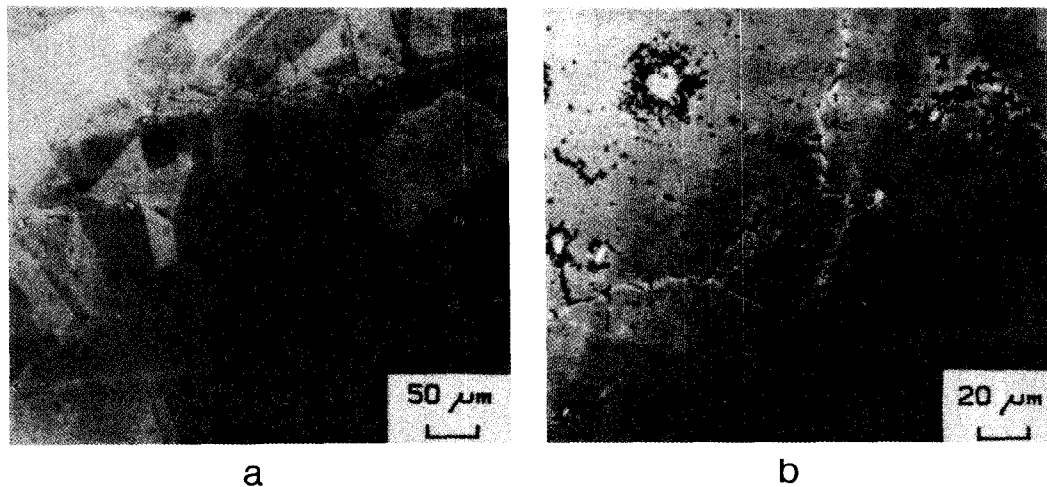
Fig. 1 Effect of "Merrick" and "Modified Merrick" heat treatments on the grain boundary structure of Alloy 718. (a) Merrick, and (b) Modified Merrick, heat treated materials.

directly after the solution treatment whereas the "Modified Merrick" heat treatment employs a furnace cool of  $\sim 7^{\circ}\text{C}$  /minute to the intermediate aging temperature. In the "Modified Merrick" heat treatment, the furnace cooling together with intermediate aging at  $843^{\circ}\text{C}$  for 4 hours produce profuse serration at the grain boundaries whereas the "Merrick" heat treatment essentially produces a planar grain boundary morphology, Fig. 1.

The results of optical and TEM examination of Alloy 718 subjected to "Merrick" and "Modified Merrick" heat treatments are compared in Table 2 and Figs. 1 and 5. The grain sizes produced by the two heat treatments are similar although their grain boundary morphologies and intragranular  $\gamma$  precipitate sizes differ markedly. The "Merrick" heat treatment produces a coarse  $\gamma$  precipitate distribution and a planar grain boundary structure whereas the "Modified Merrick" heat treatment results in a fine  $\gamma$  precipitate size and a profusely serrated grain boundary morphology.

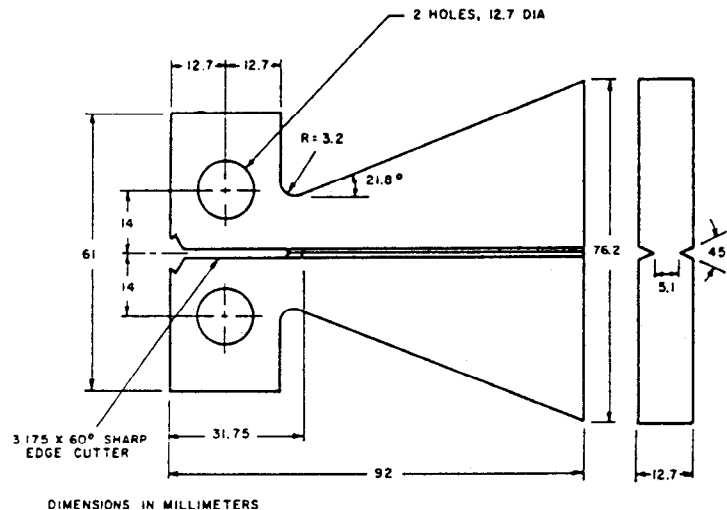
Fig. 2 Dimensions of tapered double cantilever beam specimen (DCB) used for FCGR testing. (After Thamburaj et al. Ref. 5)

All FCGR tests were conducted in electrohydraulic test systems. Tapered double cantilever beam (DCB) fracture mechanics specimens, having a constant stress intensity region over 31 mm (5), were machined from the heat treated plate stock, Fig. 2. The FCGR tests on DCB specimens were conducted at constant  $\Delta K$  values of 45 and 90 MPa  $\sqrt{\text{m}}$  in laboratory air at 650°C. The stress ratio (R) of 0.1 and a frequency of 0.1 Hz were used for DCB specimen testing using a sine wave form. Fracture surfaces were studied by scanning electron microscopy (SEM) to determine the crack growth rates and failure modes.

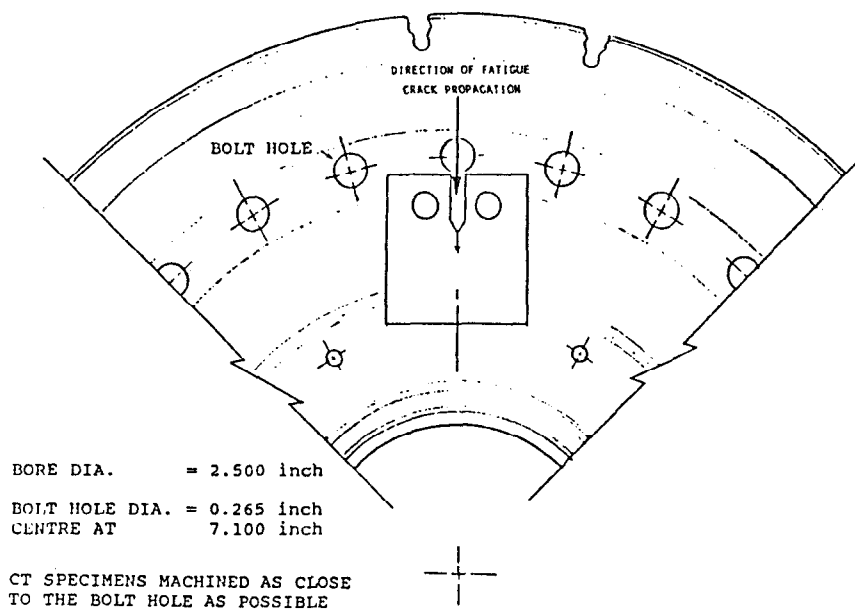
Fig. 3 Location of the compact tension (CT) specimens machined from Alloy 718 turbine discs.

To investigate the effects of dislocation substructures on fracture mechanics properties of Alloy 718, FCGR testing was performed on compact tension (CT) specimens machined from the service exposed discs. It is already known that bolt hole regions accumulate maximum damage due to stress cycling and are the fracture critical locations in these discs (9). Therefore, CT specimens were machined as close to the bolt holes as possible, Fig. 3. The CT specimens were machined in a manner such that the direction of crack propagation through the specimen was radial towards the bore of the disc. This orientation is also illustrated in Fig. 3. The geometry of the CT specimens used in this work is given in Fig. 4. The CT specimen met the ASTM standard E-647-83 minimum size recommendations in all dimensions (10). The specimen thickness was dictated by the minimum disc thickness in the bolt hole region and this corresponds to the 4.75 mm (0.187 in) dimension in Fig. 4. The CT specimen required a precrack of 6.67 mm and the final crack length was taken as 14.43 mm in order to meet the elasticity requirements as specified in ASTM standard E-647-83 (10). These crack lengths correspond to a  $\Delta K$  range of 30 to 72 MPa  $\sqrt{\text{m}}$  at an R value of 0.1. The FCGR testing was carried out at 650°C in laboratory air using a sawtooth waveform at a frequency of 1 Hz. An automated direct current potential drop (DC-PD) technique, with a precision of 0.025 mm was used to monitor the crack lengths during testing (11). The data acquisition time for the DC-PD technique was limited to 0.5 seconds per

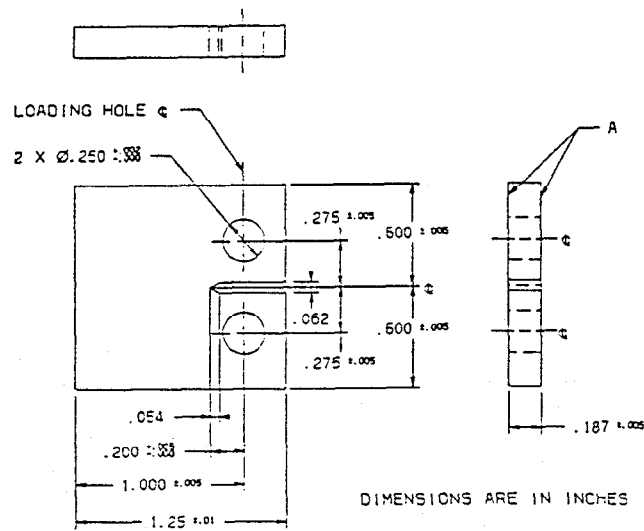
Fig. 4 Dimensions of the CT specimens machined from turbine discs.

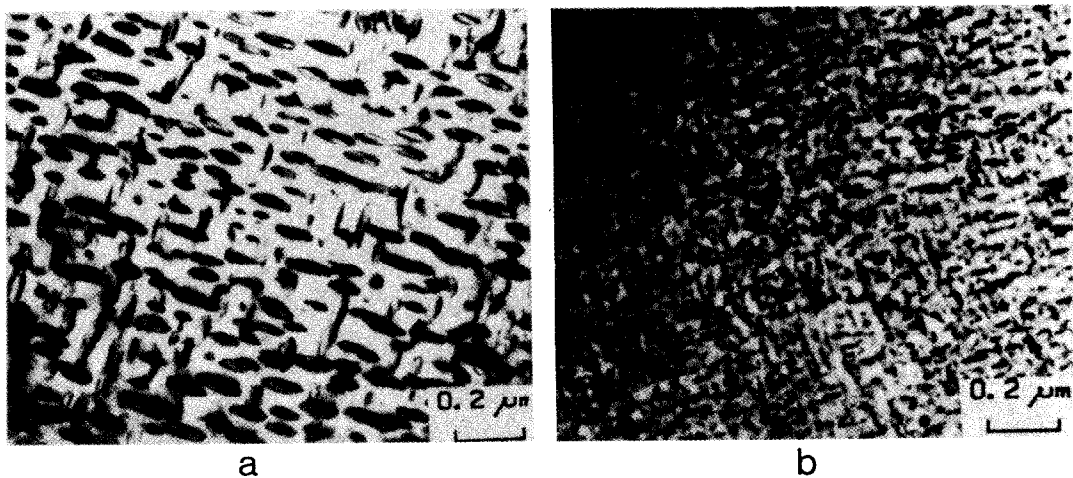
Fig. 5 Effect of "Merrick" and "Modified Merrick" heat treatments on the  $\gamma$  precipitate size and distribution in Alloy 718. (a) Merrick, and (b) Modified Merrick heat treated materials.

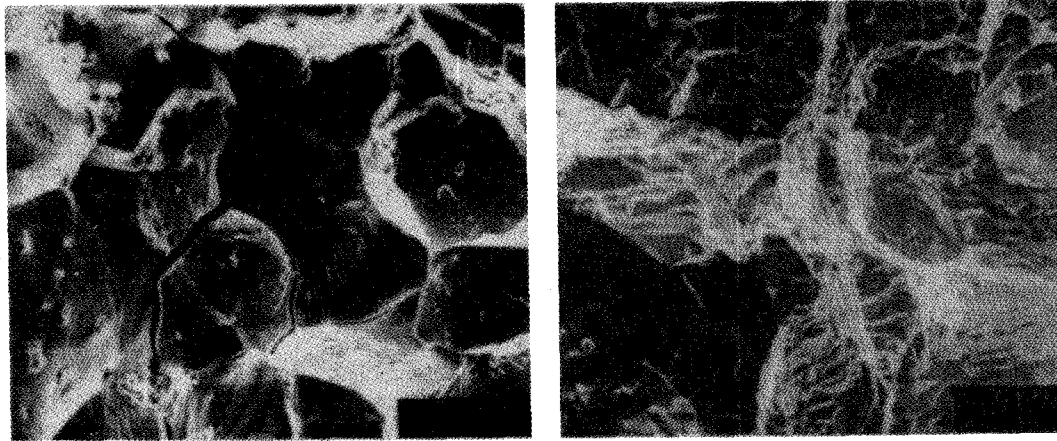
Fig. 6 Fracture modes of Alloy 718 at  $45 \text{ MPa} \sqrt{\text{m}}$  at  $650^\circ\text{C}$  in laboratory air. (a) Merrick, and (b) Modified Merrick heat treated materials.

both microstructures were intergranular at both stress intensity ranges, Figs. 6 and 7, the "Merrick" treated material showed sharp grain boundary facets whereas in "Modified Merrick" heat treated material grain boundary facets revealed stair-step appearance including the presence of some ductile features.

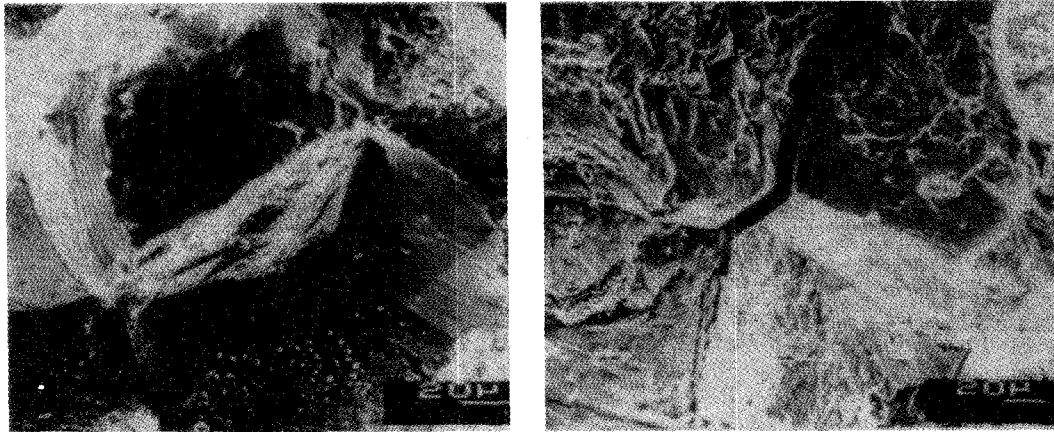
Fig. 7 Fracture modes of Alloy 718 at  $90 \text{ MPa} \sqrt{\text{m}}$  at  $650^\circ\text{C}$  in laboratory air. (a) Merrick, and (b) Modified Merrick heat treated materials.

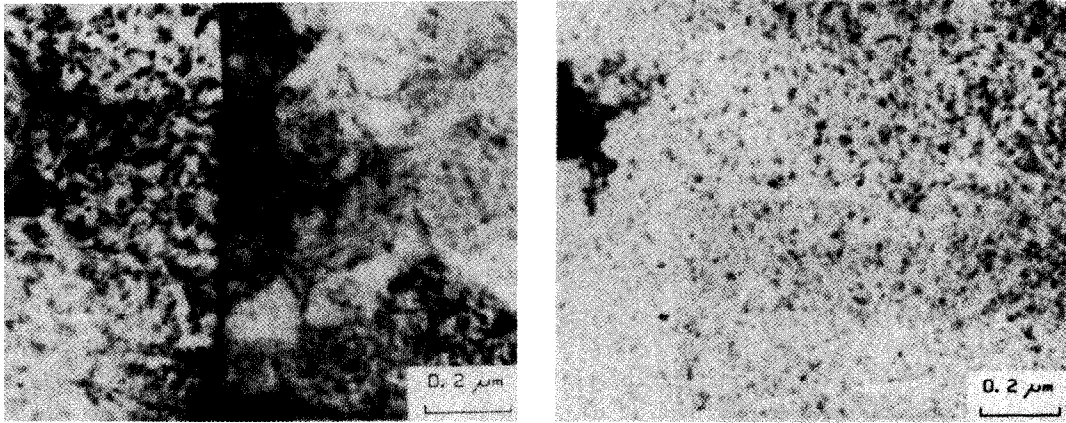
Fig. 8 Transmission electron micrographs of service exposed Alloy 718 discs showing typical  $\gamma''$  sizes and distributions. (a) Medium TSN disc and (b) High TSN disc. (After Pishva et al. Ref. 9)

The TEM observations revealed that there were no essential differences in the  $\gamma'$  and  $\gamma''$  precipitate sizes and distributions between the medium and the high TSN discs, Fig. 8. The high TSN disc, however, revealed the presence of a large number of intragranular planar dislocation arrays, Fig. 9(a), and low angle boundaries, Fig. 9(b), in the bolt hole and bore regions respectively. In contrast, the dislocation array arrangements in the medium TSN disc were cellular, Fig. 10, and there was no indication of low angle boundary formation in any region of this disc. The  $\gamma'$  and  $\gamma''$  precipitates in the vicinity of these dislocation substructures in both discs did not reveal any unusual features such as coarser  $\gamma''$  precipitates along dislocation lines. These observations indicate that these dislocation substructures had probably formed during service in both discs.

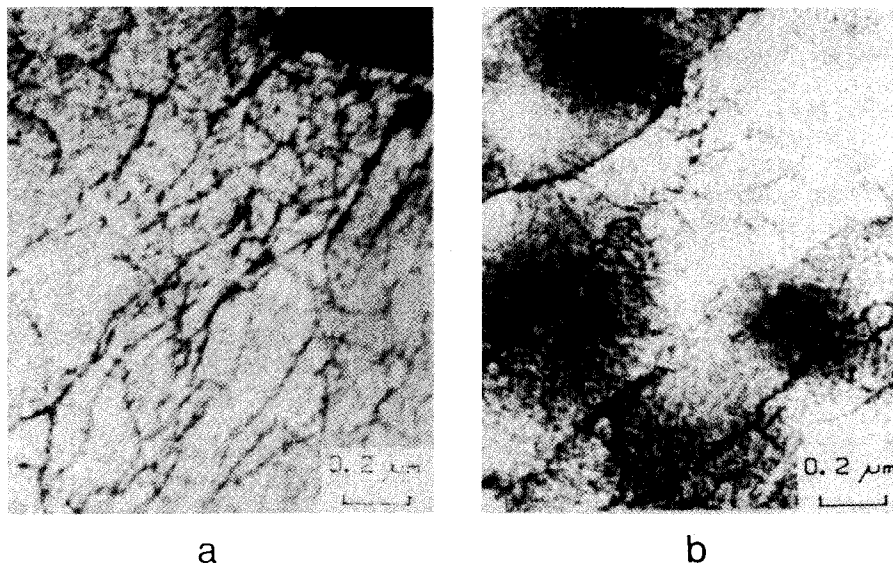
Fig. 9 Typical dislocation structures observed in the high TSN Alloy 718 disc. (a) CT specimen location (bolt hole regions) and (b) bore region. (After Pishva et al. Ref. 9)

A number of conventionally heat treated Alloy 718 plates and bars from different material heats along with new disc forgings have previously been examined in the authors' laboratory (3,5,7). None of these materials have revealed the presence of planar dislocation arrays or subgrains of the type shown in Figs. 9a and 9b respectively. Instead, these materials always contained homogeneous dislocation distributions as shown in Fig. 14.

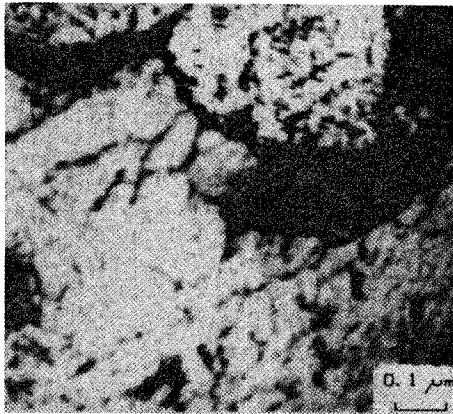
Fig. 10 Typical dislocation structures observed in the medium TSN Alloy 718 disc. (After Pishva et al. Ref. 9)

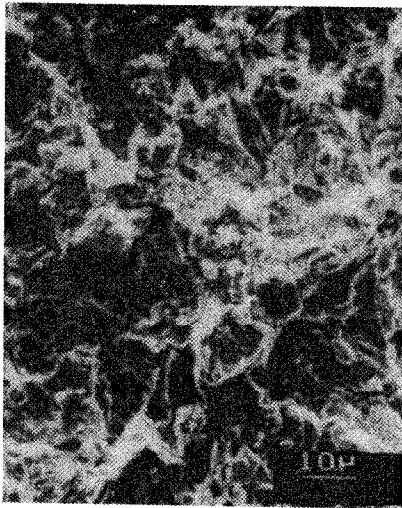
Fig. 12 Typical fracture mode observed in Alloy 718 CT specimens machined from service exposed turbine discs.

The SEM examination of the cracked CT specimens from both discs revealed a mixed intergranular and transgranular mode of fracture, Fig. 12, indicating that the differences in dislocation substructures do not influence the actual failure mechanism.

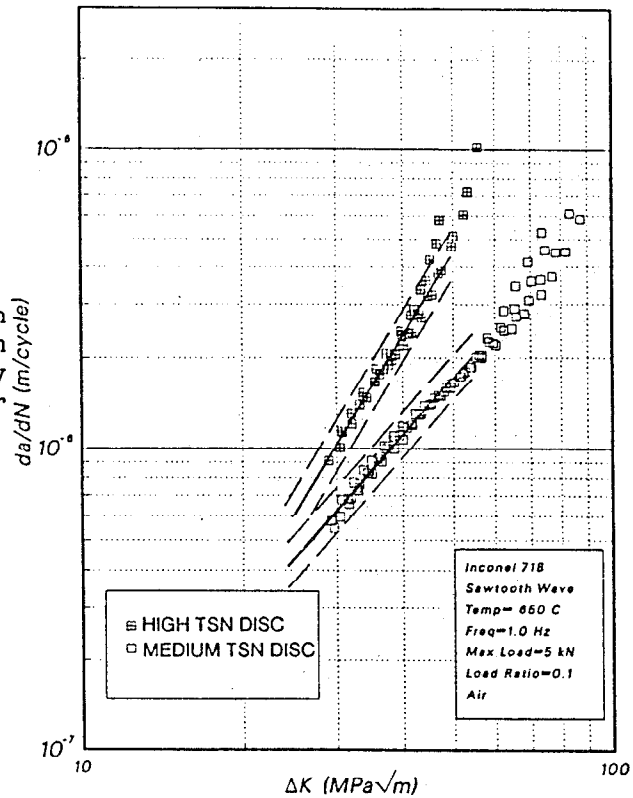
Fig. 11 The FCGR data generated on CT specimens machined from medium and high TSN Alloy 718 discs at 650°C in air environment. (After Pishva et al. Ref. 9)

The FCGR data generated on CT specimens from the medium and high TSN discs showed a large amount of scatter and these data are compared in Fig. 11. The solid lines and the two parallel dashed lines in Fig. 11 represent the mean line and the  $\pm 3$  conditional standard deviations from the mean within Paris regime of crack growth. Relative to the medium TSN disc, the high TSN disc specimens revealed FCGR's that were higher by a factor of 2 to 5 over a  $\Delta K$  range of 30 - 55  $\text{MPa}\sqrt{\text{m}}$ , Fig. 11. The FCGR data within the tertiary regimes of crack growth indicate that the fracture toughness of the medium TSN disc is considerably higher than the high TSN disc.

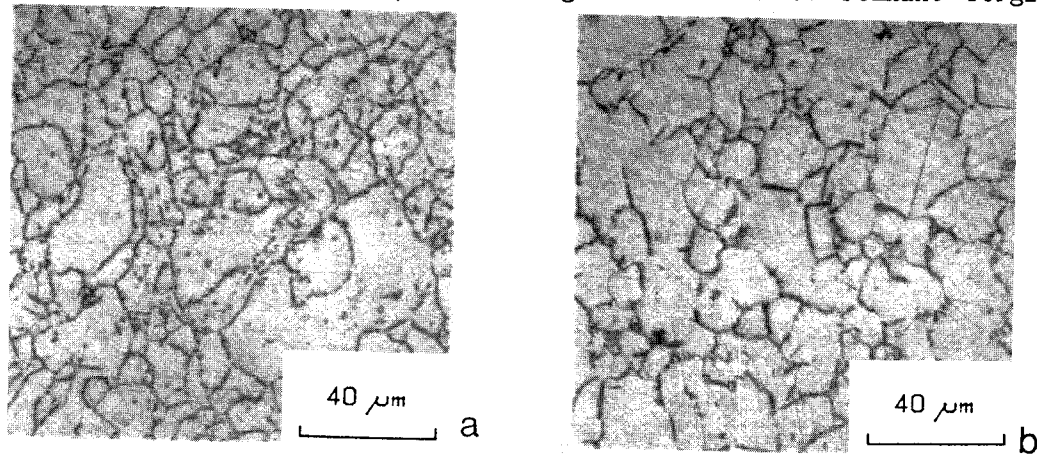
Fig. 13 Optical micrographs of Alloy 718 turbine discs in CT specimen locations. (a) High and (b) Medium TSN discs.

Dislocation substructures in turbine discs can be introduced either due to plastic deformation during forging or due to stress cycling during engine operation. Stress cycles associated with engine start-up, shut-down and major throttle excursions during service can lead to low cycle fatigue damage accumulation, i.e. plastic strain accumulation prior to crack initiation. The Alloy 718 discs examined in this study had been upset hammer forged at a starting forging temperature of 1050°C and the rim and the bore areas had been subjected to additional deformation at a starting forging temperature of 1000°C. The discs had then been partially solution treated well above the  $\gamma'$  solvus (871°C) or the  $\gamma''$  solvus (900°C) at 955°C for 1 hour. A partial solution treatment temperature of 955°C corresponds to 0.75 - 0.8  $T_m$  for the alloy. In the absence of intragranular  $\gamma'$  or  $\gamma''$  precipitates, the forging induced dislocation networks may either annihilate or rearrange to form a recrystallized grain structure because of the low stacking fault energy of Ni-base superalloys. Both discs revealed equiaxed recrystallized grain structures in the CT specimen locations, Fig. 13, indicating the absence of remnant forging

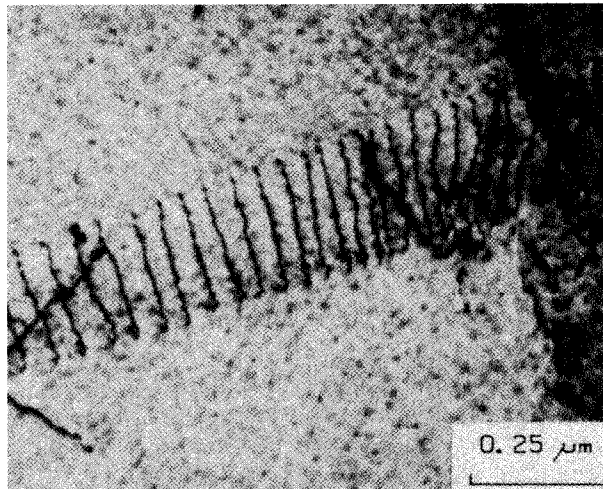
Fig. 14 Typical dislocation structures observed in virgin Alloy 718 forgings.
