## CRYSTALLOGRAPHIC INITIATION OF NICKEL-BASE SUPERALLOY IN100 AT RT AND 538°C UNDER LOW CYCLE FATIGUE CONDITIONS

K. Li<sup>†</sup>, N.E. Ashbaugh<sup>†</sup>, and A.H. Rosenberger

Air Force Research Laboratory, Material & Manufacturing Directorate, AFRL/MLLMN,  
Wright-Patterson AFB, OH 45433-7817, USA

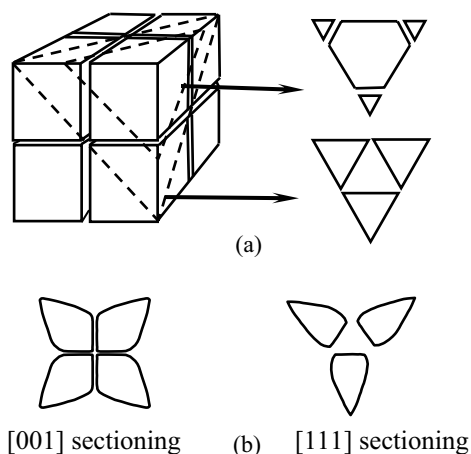
Figure 1. {111} Fracture surface facets: (a) sectioning of a perfect octahedrally diced cube on {111} and (b)  $\gamma'$  shape under {001} and {111} sectioning associated with an effect of preferential growth along [111] at vertices [4].
