FEMTOSECOND LASER MICROMACHINING OF SINGLE-CRYSTAL SUPERALLOYS

Q. Feng¹, Y. N. Picard¹, H. Liu², S. M. Yalisove¹, G. Mourou² and T. M. Pollock¹

¹University of Michigan, Department of Materials Science and Engineering, Ann Arbor, MI 48109

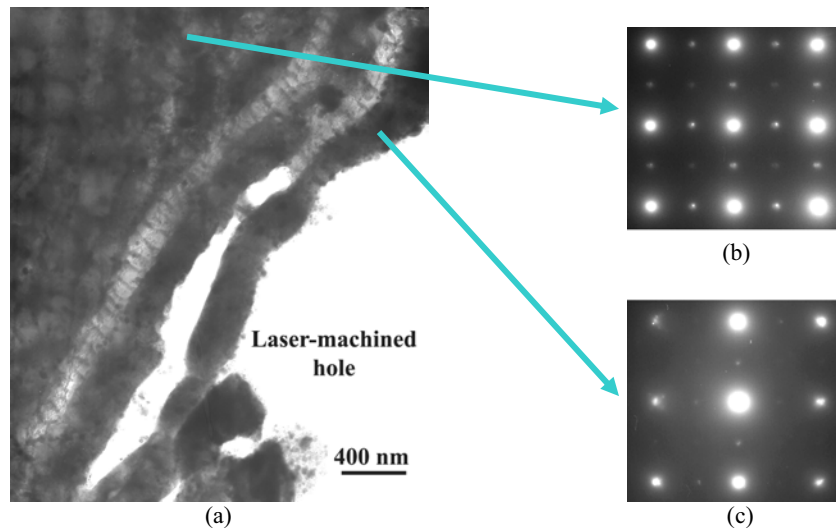
Figure 6. Single crystal alloy MK-4, (a) a bright-field TEM image of laser-induced deformation microstructure in region 1 of Figure 5, (b) and (c) are SAD patterns in the $\langle 001 \rangle$ zone-axis taken from the areas marked in (a), revealing the same crystal structure with the same orientation in both areas, indicating that no melting occurred during laser machining.

Selected area electron diffraction (SAD) analyses were conducted in the area adjacent to the laser-machined hole in order to assess the crystalline nature of the remaining material. Figure 6(a) is a bright-field TEM image of the microstructure in region 1 and the areas for SAD analyses are marked by arrows. Figure 6(b) shows the SAD pattern in the $\langle 001 \rangle$ zone axis of the $(\gamma + \gamma')$ matrix including superlattice diffraction spots of the γ' phase. It is important to note that it is the same diffraction pattern as observed in regions 2 and 3. There were, however, a few degrees of deviation due to the foil bending. The SAD pattern taken at the hole edge is shown in Figure 6(c) and again presents the $\langle 001 \rangle$ zone-axis diffraction pattern of the γ phase, which also contained the diffuse superlattice spots of the γ' phase. Electron diffraction analyses clearly indicate that the material remaining in region 1 maintained its monocrystalline character with the same crystal structure and orientation as observed in regions 2 and 3. This suggests that no material transformed from monocrystalline to polycrystalline or even became amorphous material during laser processing. These direct observations also clearly indicate that no melting occurred near the ablated region during femtosecond laser processing. The slightly more diffuse γ' superlattice diffraction

spots shown in Figure 6(c) may occur for several reasons: 1) the material, including the $(\gamma + \gamma')$ phases, was heavily deformed, 2) the material consisted of a higher volume fraction of the γ phase within the first 400 nm of the machined hole, relative to the base material or 3) some slight preferential vaporization of Al reduced the volume fraction of precipitates.

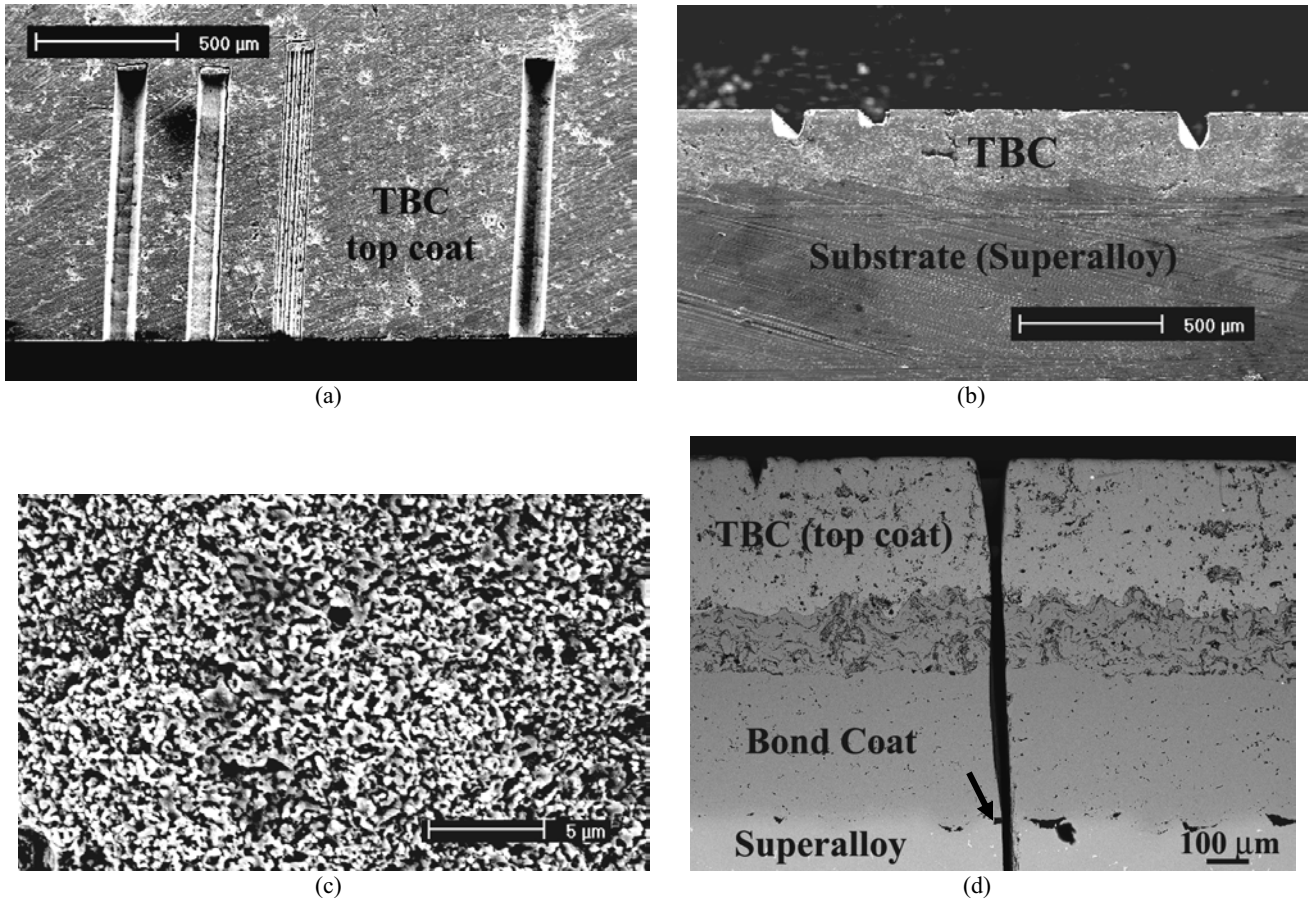
Figure 9. SEM images of the trenches machined by a femtosecond laser in the TBC-coated superalloy showing no laser-induced processing defects, such as microcracking and recast laser, etc., (a) and (b) are plan view and cross-section view of the trenches machined inside the top coat (ceramic layer), (c) typical microstructure of the trench surface, (d) BSE image, showing the trench machined through top coat/bond coat and bond coat/superalloy interfaces.

Figure 9(a) is a SEM image of the plan-view of a YSZ ceramic layer (top coat) in the TBC-coated superalloy, showing four trenches in the ceramic layer machined by a femtosecond laser operating at the fluence of 160 J/cm². From the top view, no cracks, spatter or plasma debris were observed around the trenches. The cross-sectional view of the same TBC-coated sample through the laser-machined trenches is shown in Figure 9(b). Again there was no obvious laser-induced microcracking or recast layers around these trenches in the ceramic layer. Figure 9(c) is a SEM image at a higher magnification, presenting the typical microstructure of the trench surface after the femtosecond laser micromachining. It shows the laser-induced sub-micron roughness that is typical of femtosecond machined surfaces in a wide range of materials including metals and glass [8, 21].

Figure 9(d) is a backscattered-electron (BSE) SEM image, showing the cross-sectional view of a trench, machined by a femtosecond laser operating at the fluence of 18 J/cm². The trench was drilled through the top coat/bond coat and bond coat/superalloy interfaces. It should be noted that the machining process did not produce any delamination of the top coat/bond coat or bond coat/superalloy interfaces, even the trench passed through a defect at the bond coat/superalloy interface (marked by

an arrow) during laser machining. These interfaces are well known as sites for laser-induced damage via conventional processes, due to high mismatch in thermal expansion coefficients of the different layers of materials in TBC-coated superalloys [23].
